INSPECTION REPORT: GREENS CREEK MINE

Date of Inspection: Wednesday, January 30, 2019
Date of Report: Wednesday, February 13, 2019
USDA Forest Service Inspector: Richard Dudek

The site inspection included the A-road (0.8 mile marker), B-road, 920 area, 860 area, Site 23, 7.4 mile B-road Bridge (Killer Creek Bridge), 3.4 mile B-road Bridge (Falls Creek Bridge), 3.0 mile B-road Bridge (Zinc Creek Bridge), and the Tailings Disposal Facility (TDF).

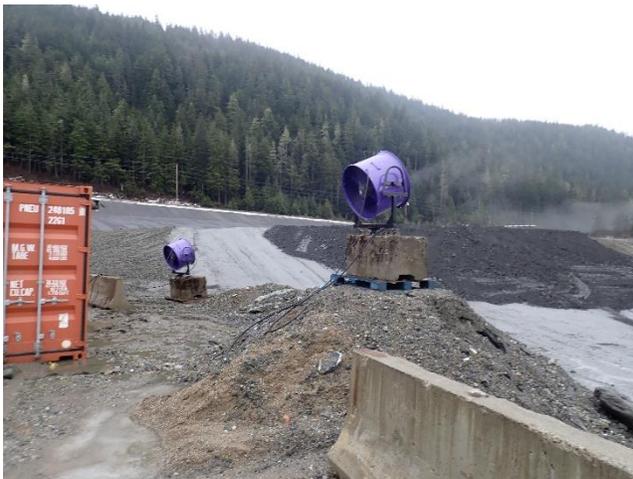
- **HGCMC personnel continue to work on the installation of the currently non-operational TDF water misting system (Photo 1).**
- **To improve sediment management, HGCMC Surface Operations will be attaching wood boards to all of the B-Road Bridge ends (Photo 2).**

Photo 1. The TDF water misting system.

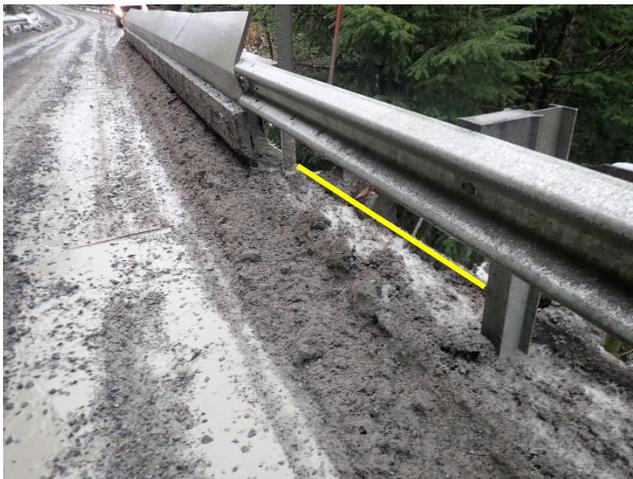
Photo 2. Wooden boards used as sediment barriers are attached at the bridge ends. This barrier highlighted in yellow is covered in snow mixed with sediments.

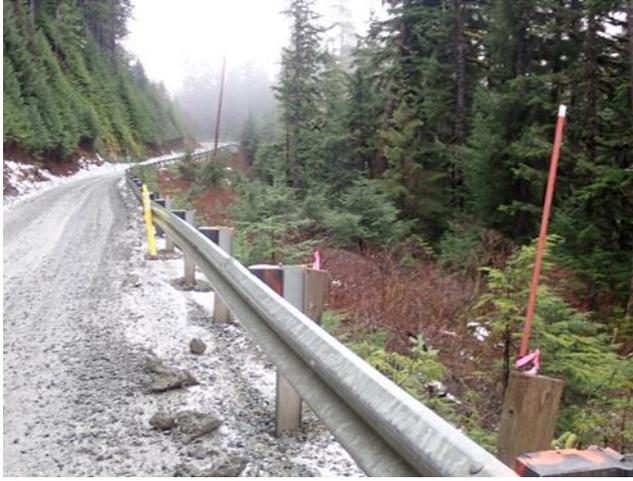
Once the survey/inspection of the failed portion of the A-road (.8 mile marker) was completed by a contractor, their results were submitted to HGCMC. As a result, Surface Operations cleaned several nearby culverts in order to improve drainage (Photo 3).

Photo 3. The section of the A-road (0.8 mile marker) where the shoulder failed.

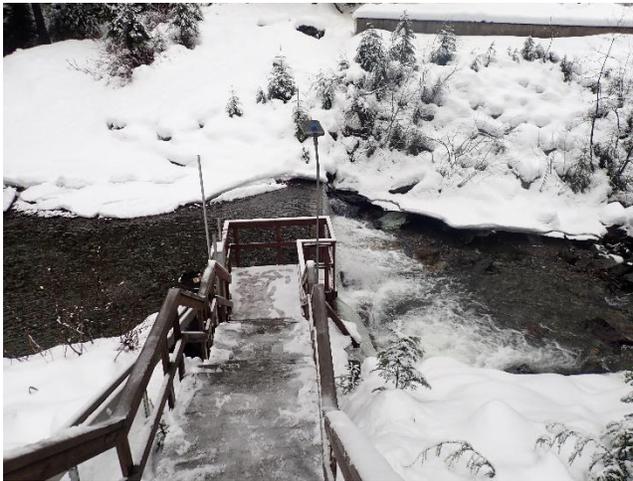
The recorded flow rate for the Greens Creek weir (Photo 4) on 01/30/2019 was 23.24 cubic feet per second (cfs). The 920-area water withdrawal rate from Greens Creek was 1.5 cfs.

Photo 4. Greens Creek weir.

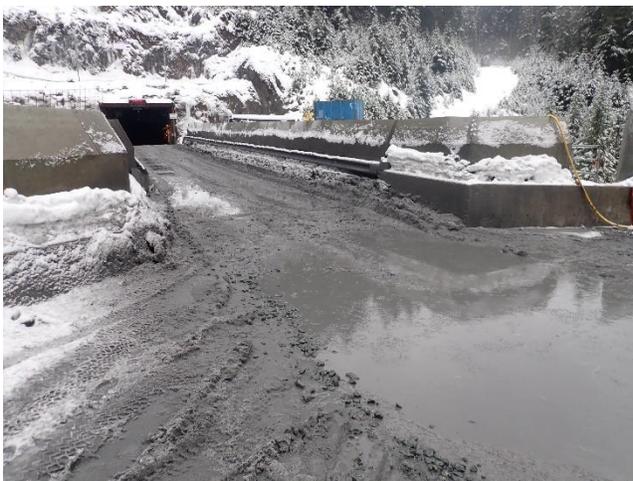
The 920 Bridge is being properly maintained and the splashguards are effective in preventing sediment splash over from vehicular traffic (Photo 5). During the site visit, David Landes from the HGCMC Environmental Department hand dug a small trench to help route pooling water from the road to DB-01.

Photo 5. The 920 Bridge.

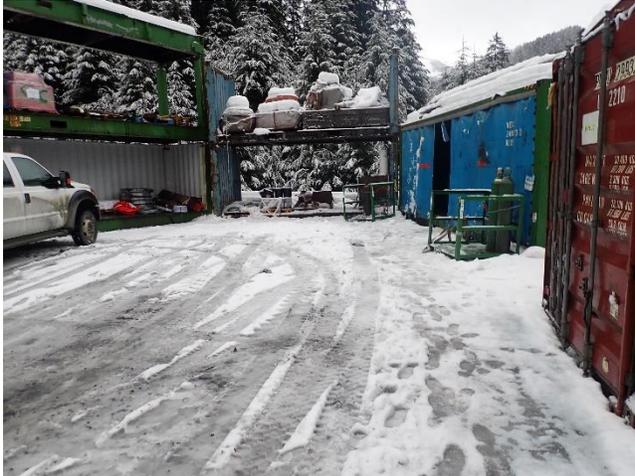
The 920 warehouse was tidy and in order (Photo 6). All petroleum and chemical products were properly stored within secondary containment (Photo 7).

Photo 6. 920 warehouse area.

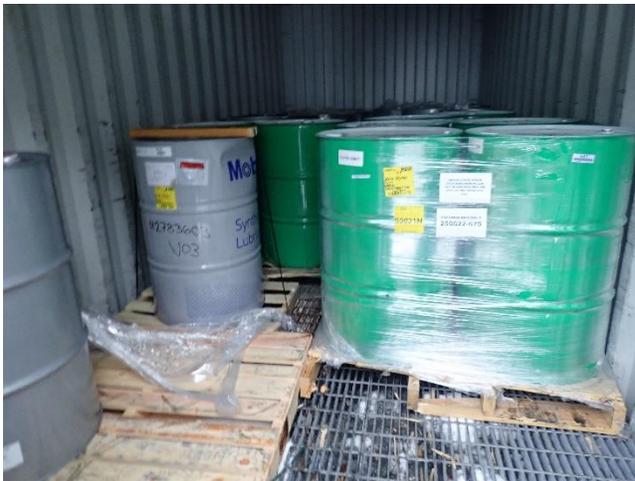
Photo 7. A storage container for petroleum products.

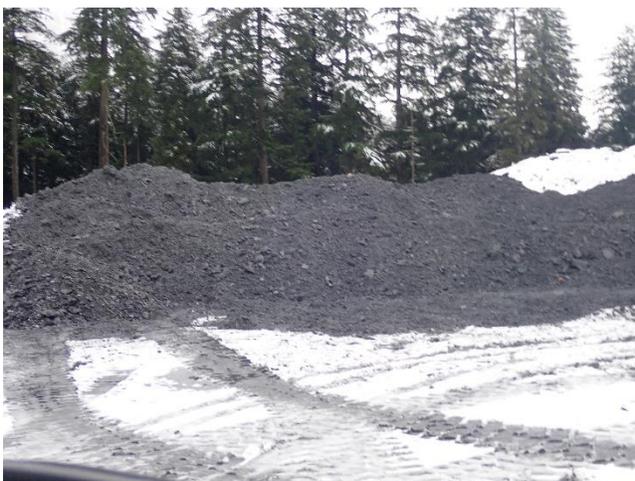
HGCMC continues to stock pile class 1, and class 2/3 waste rock (Photos 8-9) at this location (Appendix 1 Integrated Monitoring Plan; page 3-1).

Photo 8. Class 1 waste rock is staged along the perimeter of site 23.

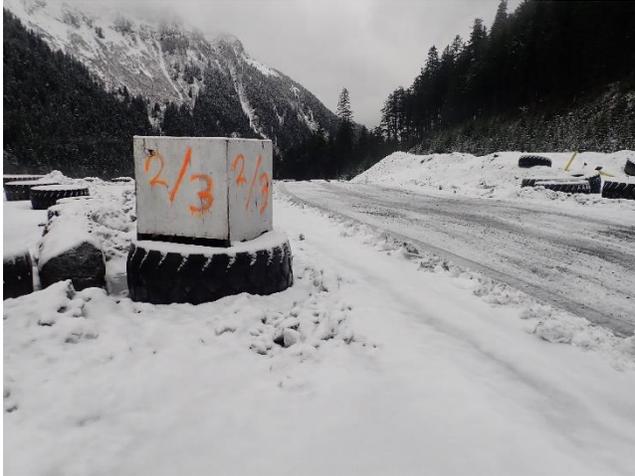
Photo 9. Class 2/3 waste rock.

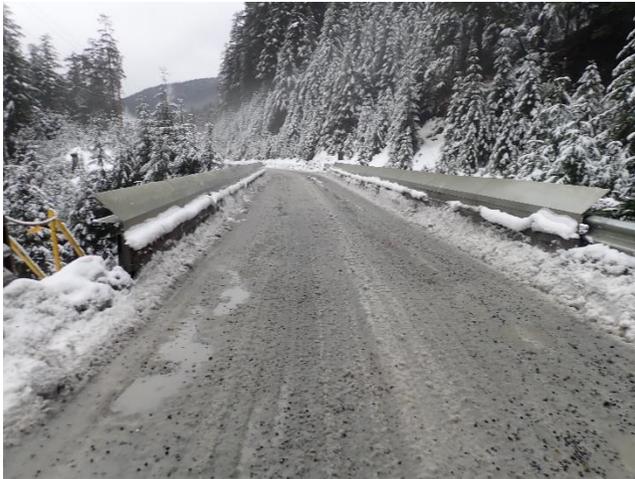
The bridge's decking is being adequately maintained by HGCMC Surface Operations (Photo 10). The bridges splashguards are effective in preventing sediment splash over from vehicular traffic (Photo 11).

Photo 10. 7.4 Mile B-Road Bridge (Killer Creek Bridge).

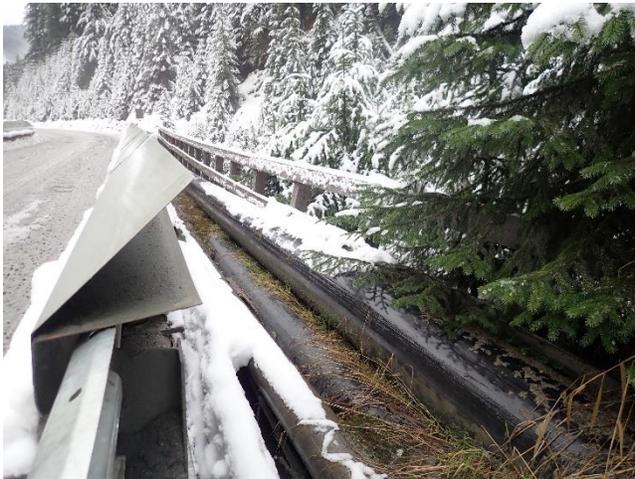
Photo 11. A section of splashguard for Killer Creek Bridge.

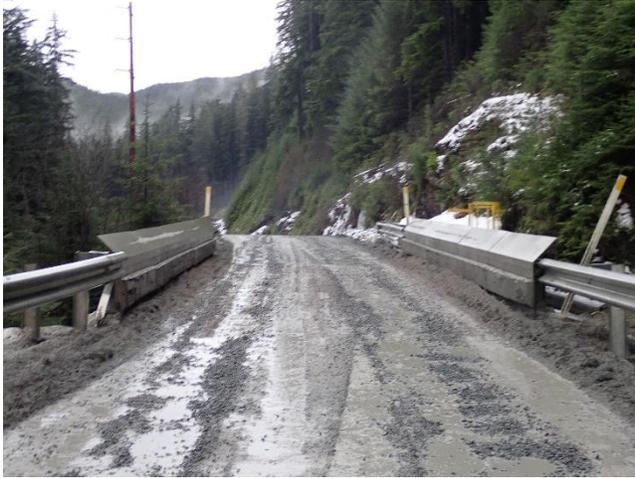
The bridge's decking is being properly maintained by HGCMC Surface Operations (Photo 12). The bridges splashguards are effectively working to prevent sediment splash over from vehicular traffic (Photo 13).

Photo 12. 3.4 Mile B-Road Bridge (Falls Creek Bridge).

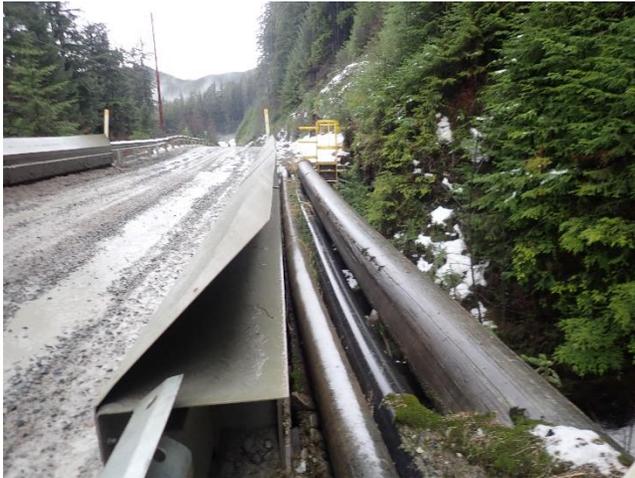
Photo 13. A view of the splashguards effectively working to prevent sediment splash over.

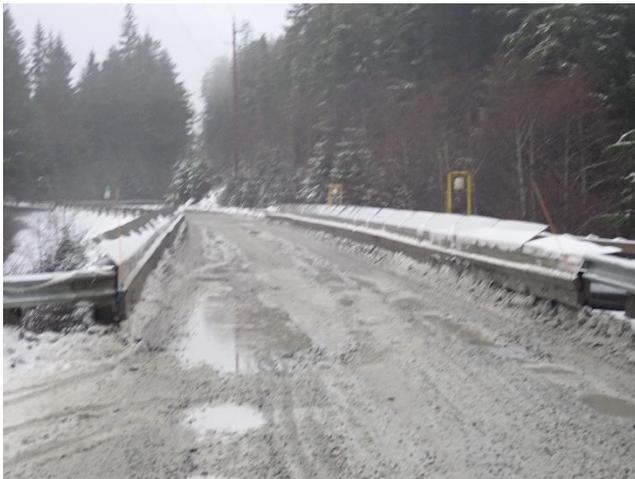
HGCMC Surface Operations are maintaining the bridge, and the BMPs at the abutment are covered in snow and ice (Photos 14-15).

Photo 14. 3.0 Mile B-Road Bridge (Zinc Creek Bridge).

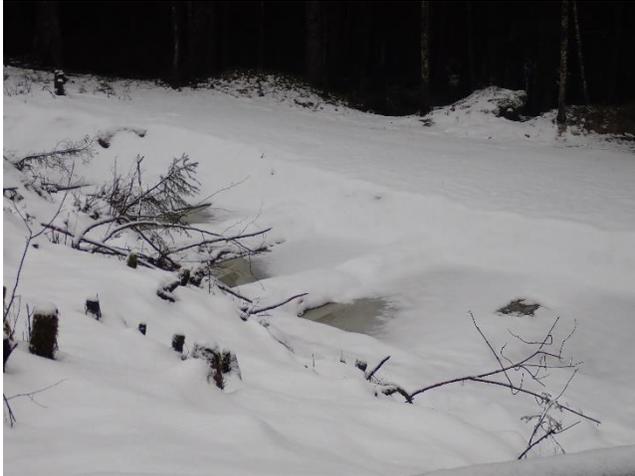
Photo 15. Structural BMPs covered in snow.

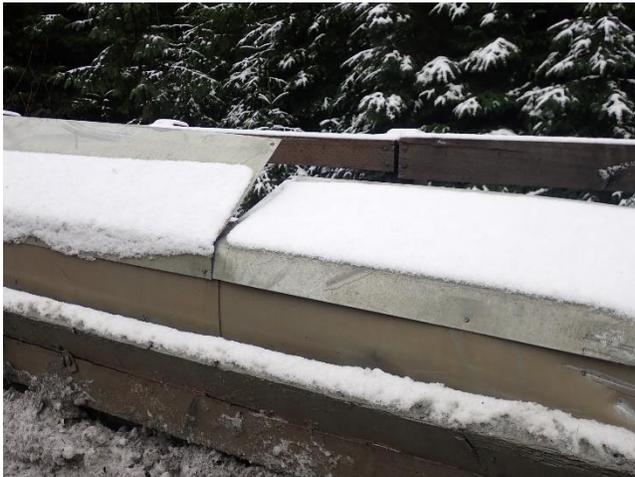
Photo 16. The damaged section of splashguard at the Zinc Creek Bridge.

HGCMC Surface Operations plan on repairing a section of the bridges splashguard that was damaged during routine snow plowing (Photo 16).

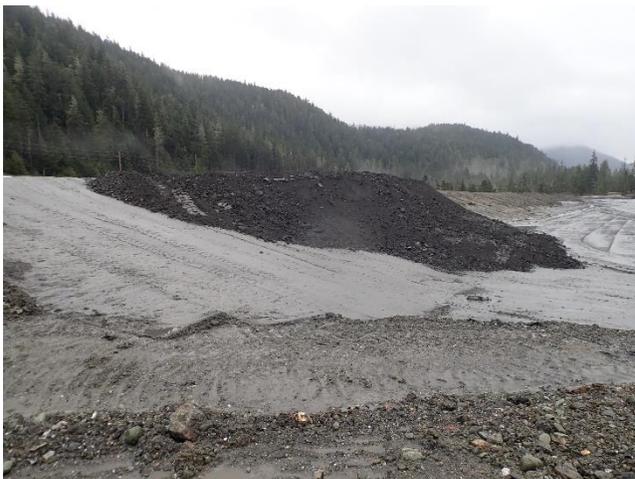
Surface Operations continue to deposit tailings in the S3P1 expansion area (Photo 17).

Photo 17. Tailings recently deposited in the S3P1 TDF area.

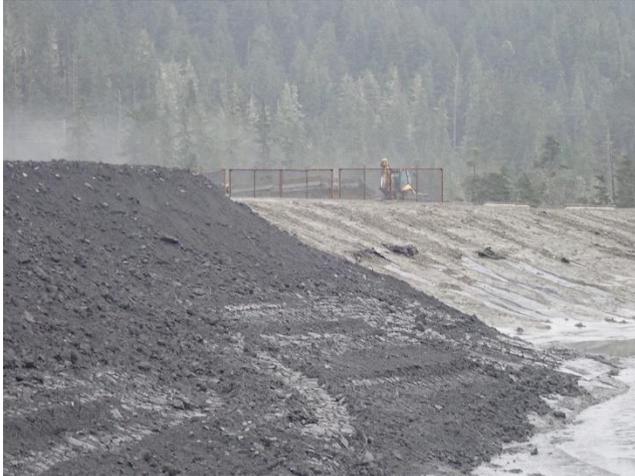
As a fugitive dust mitigation, HGCMC personnel continue to use portable wind screens (Photo 18) in active tailings placement areas.

Photo 18. Portable windscreens are used to help mitigate fugitive dust dispersal.

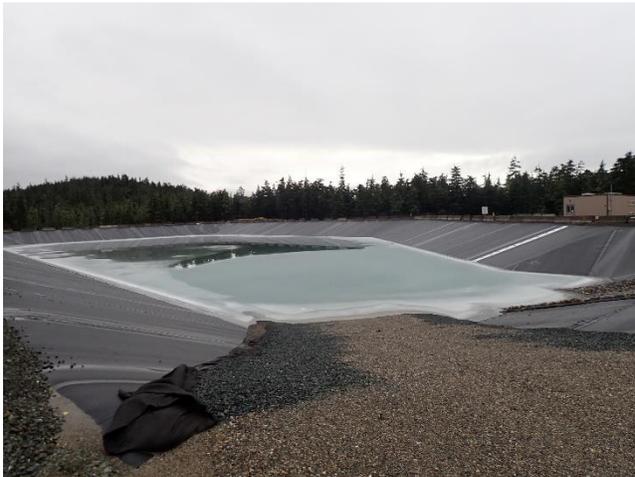
Pond 7 (Photo 19) was receiving contact water, and Pond 10 (Photo 20) is collecting direct precipitation.

Photo 19. Pond 10.

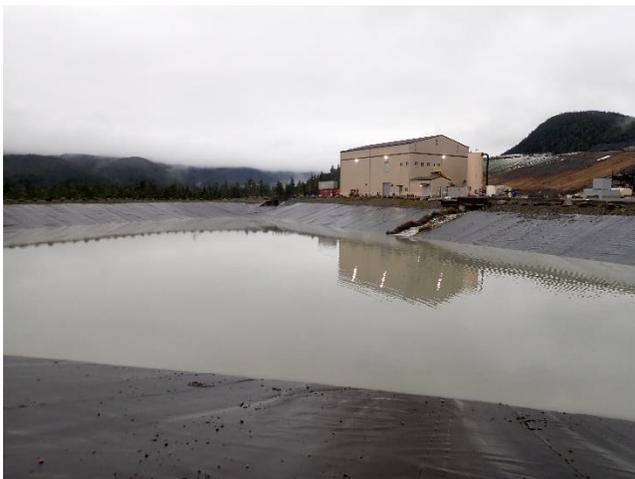
Photo 20. Pond 7.

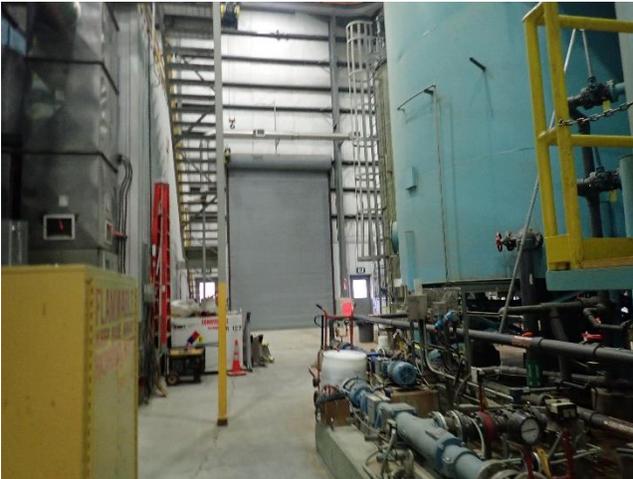
On 01/30/2019 the water treatment plant was treating 1,300 gallons per minute (gpm). Good housekeeping practices were observed inside the water treatment plant (Photo 21).

Photo 21. The TDF water treatment plant.
